# Intel® Pentium® 4 Processor

## Specification Update

*September 2003*

Document Number: 249199-041

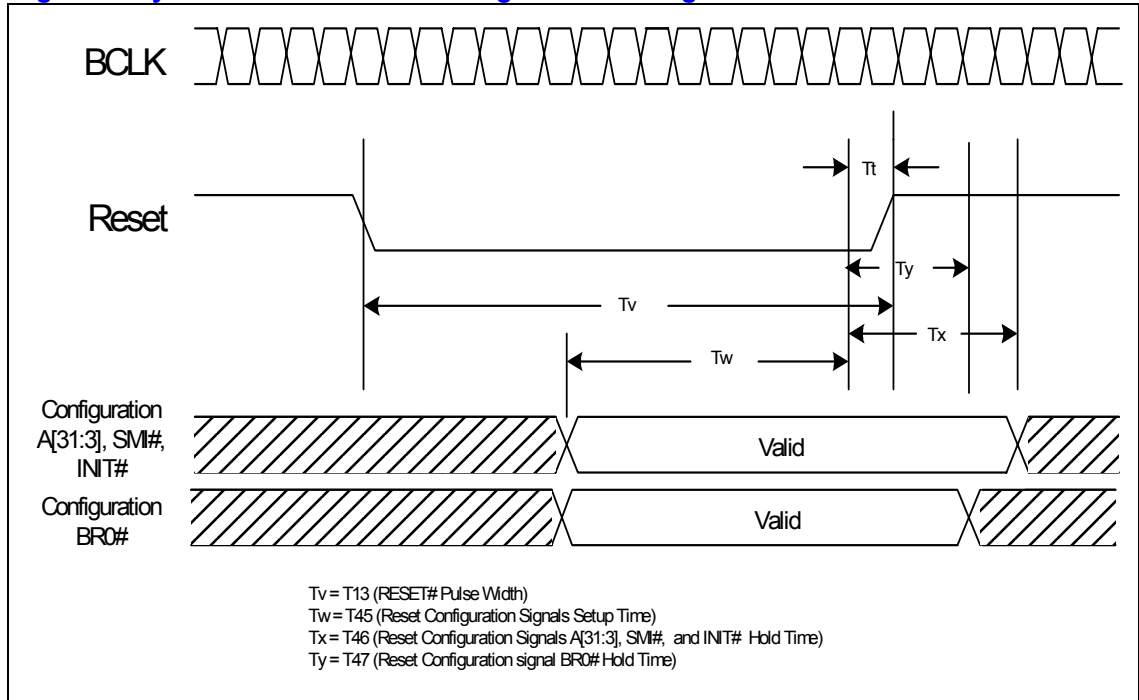
**Figure System Bus Reset and Configuration Timings**

The BR0# maximum hold time has changed to 2 BCLKs. This change will be shown in the “System Bus AC Specifications (Reset Conditions)” table and “System Bus Reset and Configuration Timings” figure of the Intel(R) Pentium(R) 4 Processor with 512KB L2 Cache on 0.13 Micron Process EMTS & Intel(R) Pentium(R) 4 Processor in the 478-pin Package Electrical, Mechanical, and Thermal Specifications (EMTS) & Intel(R) Pentium(R) 4 Processor in the 423-pin Package Electrical, Mechanical, and Thermal Specifications (EMTS). These changes will be incorporated in the next revision of the EMTS (Datasheet).

The following figure will be modified to reflect this change:
